HISTORIC AMERICAN BUILDINGS SURVEY
INVENTORY

2. NAME *Orrin Thompson Mansion*

DATE OR PERIOD *1832*
STYLE *Greek Revival*
ARCHITECT
BUILDER *Orrin Thompson*

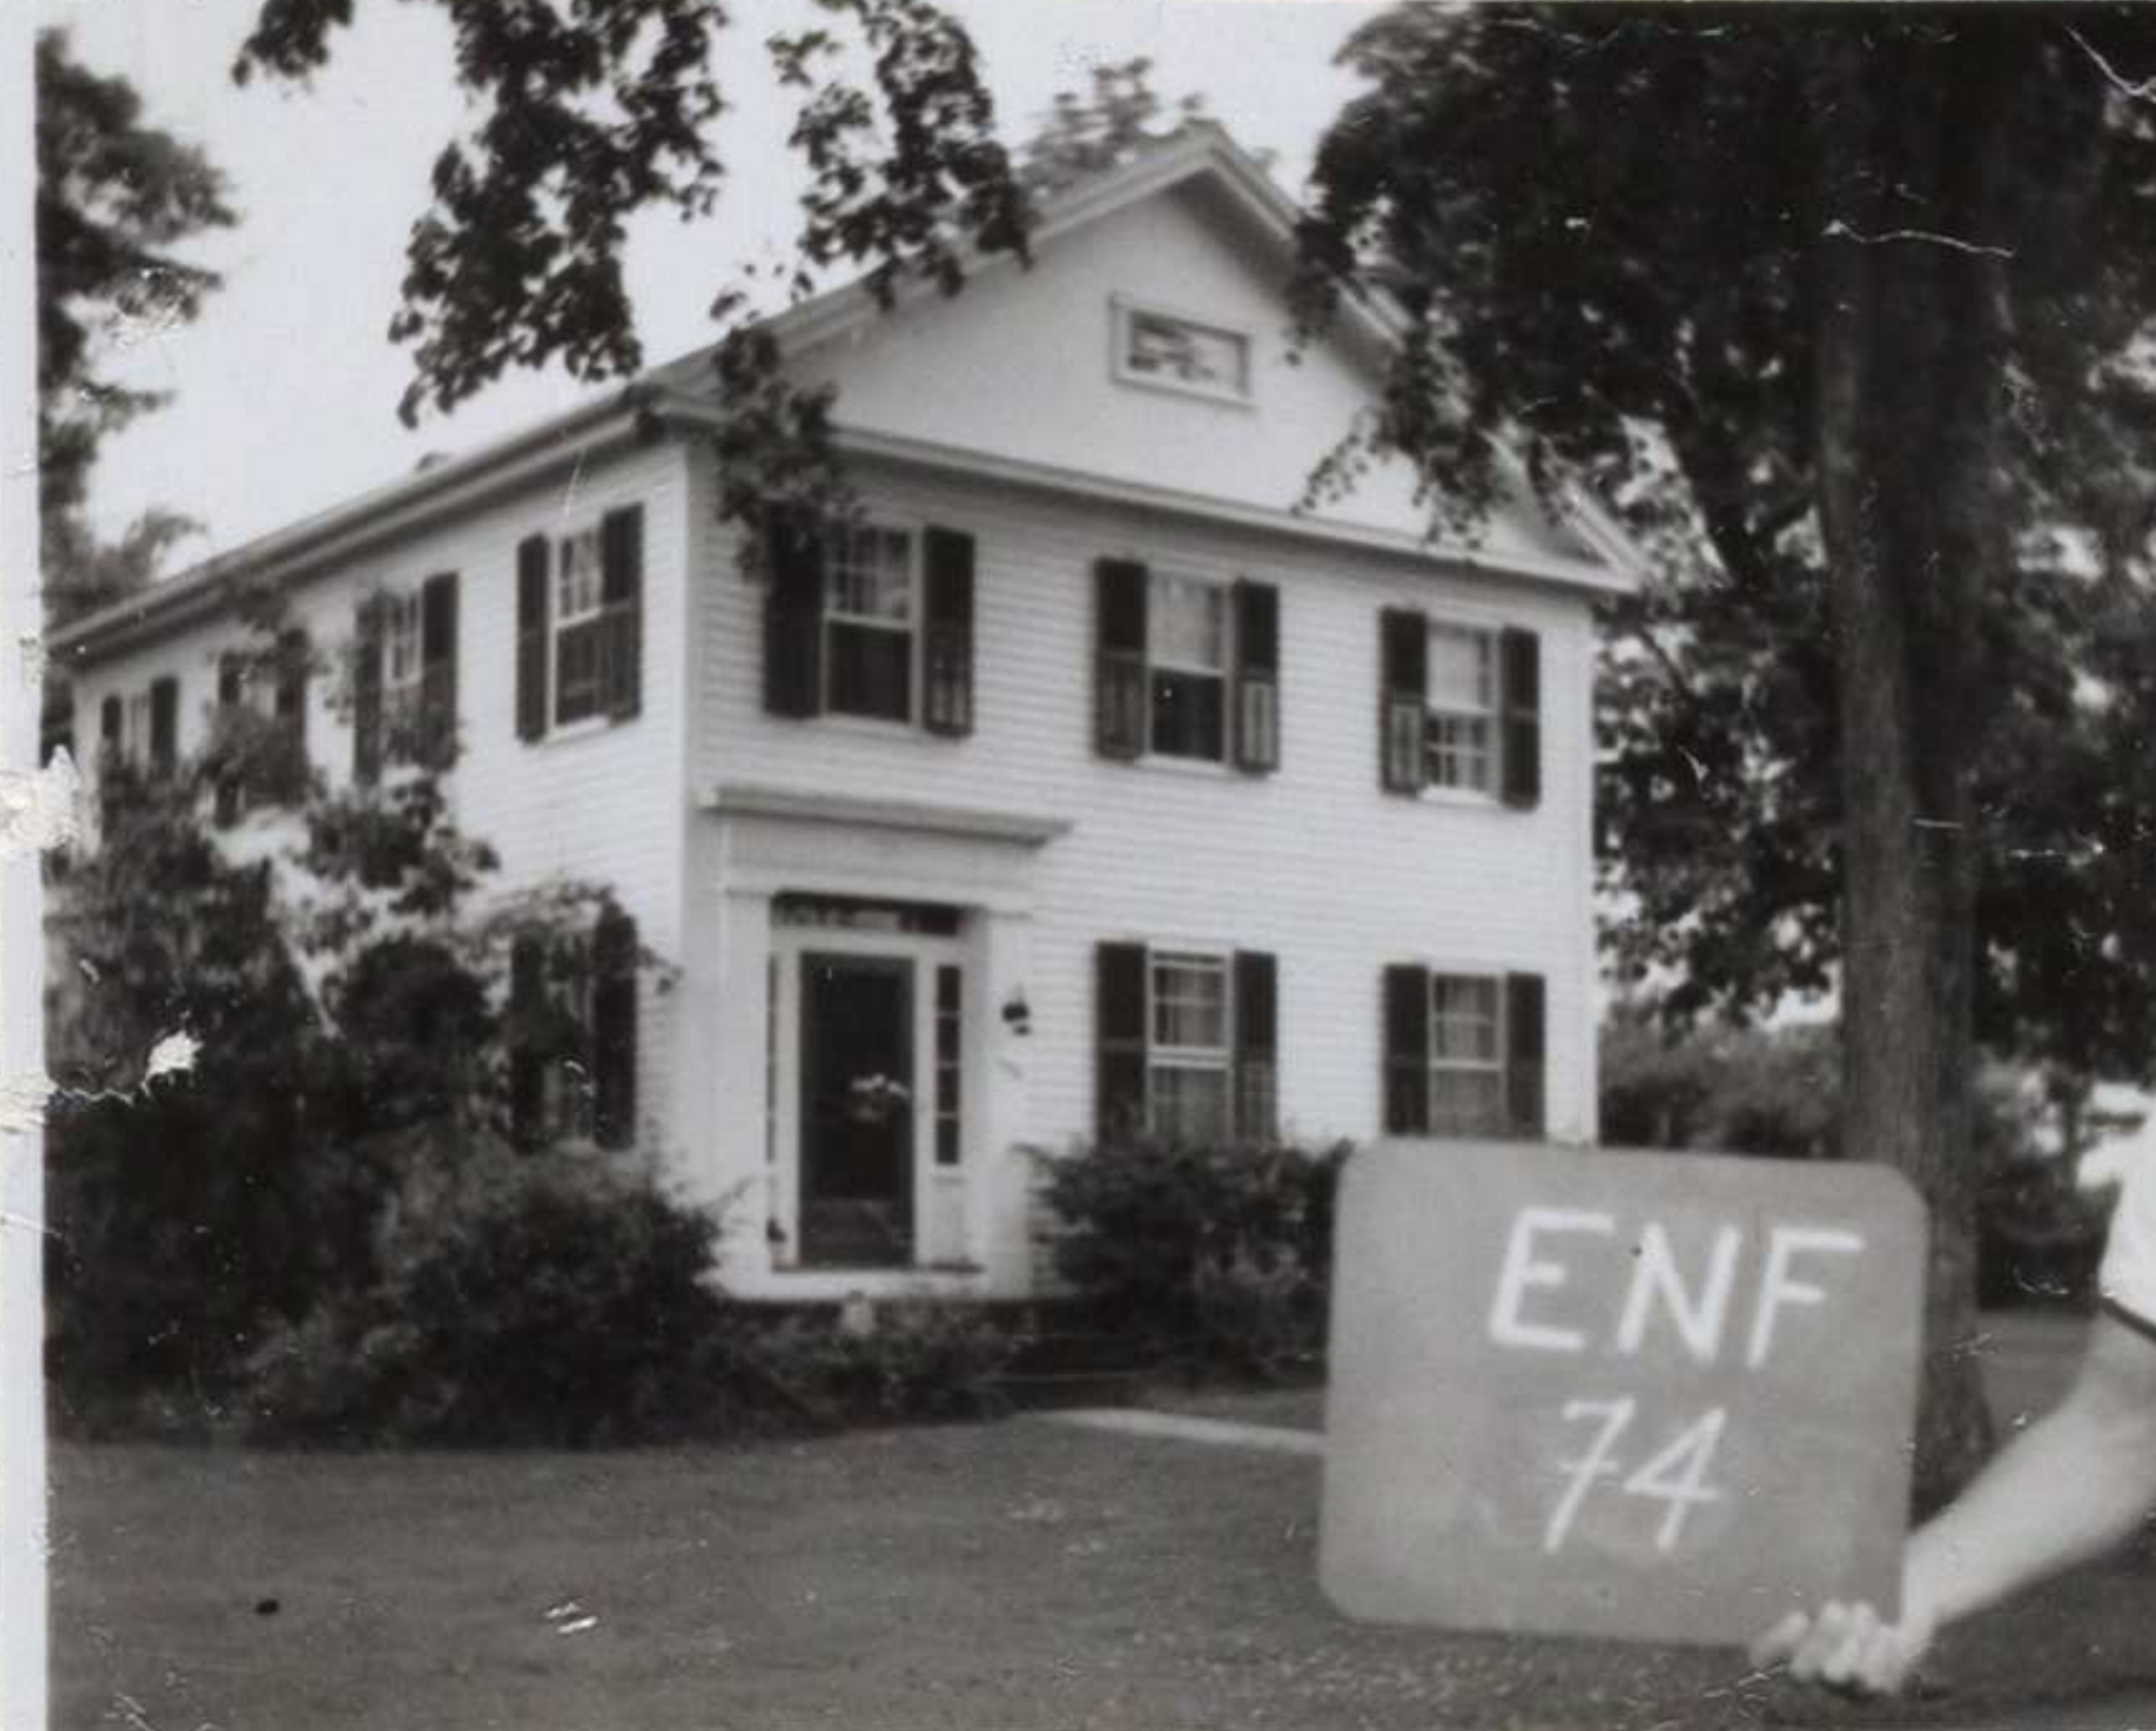
<p>7. PHOTOGRAPH <i>Enf 74</i></p>

<p>1. STATE <i>CT</i> COUNTY <i>Hartford</i> TOWN <i>Enfield</i> VICINITY STREET NO. <i>1336 Enfield St.</i></p> <p>ORIGINAL OWNER? ORIGINAL USE <i>Residence</i> PRESENT OWNER? PRESENT USE <i>Residence</i> WALL CONSTRUCTION <i>Clapboard</i> NO. OF STORIES <i>2</i></p>	<p>HISTORIC AMERICAN BUILDINGS SURVEY INVENTORY</p> <p>2. NAME</p> <p>DATE OR PERIOD <i>1820?</i> STYLE <i>Early Greek Revival</i> ARCHITECT BUILDER</p> <p>3. FOR LIBRARY OF CONGRESS USE</p>
<p>4. NOTABLE FEATURES, HISTORICAL SIGNIFICANCE AND DESCRIPTION</p> <p style="text-align: right;">OPEN TO PUBLIC <i>No</i></p> <p><i>Built on a brownstone foundation this three bay Revival house has plain boarded pediment formed by a shallow pitched roof. This is decorated by a window exactly the same as those in #57. The other windows are 6/6 with moldings. The house is cornered in plain pilasters supporting a plain entablature. The doorway has the conventional transom and side-lights. There is an original ell and other additions. To the sides the house is four bays long and has a central chimney.</i></p>

<p>5. PHYSICAL CONDITION OF STRUCTURE</p> <p>Endangered <i>No</i> Interior <i>good</i> Exterior <i>good</i></p>	
<p>6. LOCATION MAP (Plan Optional)</p>

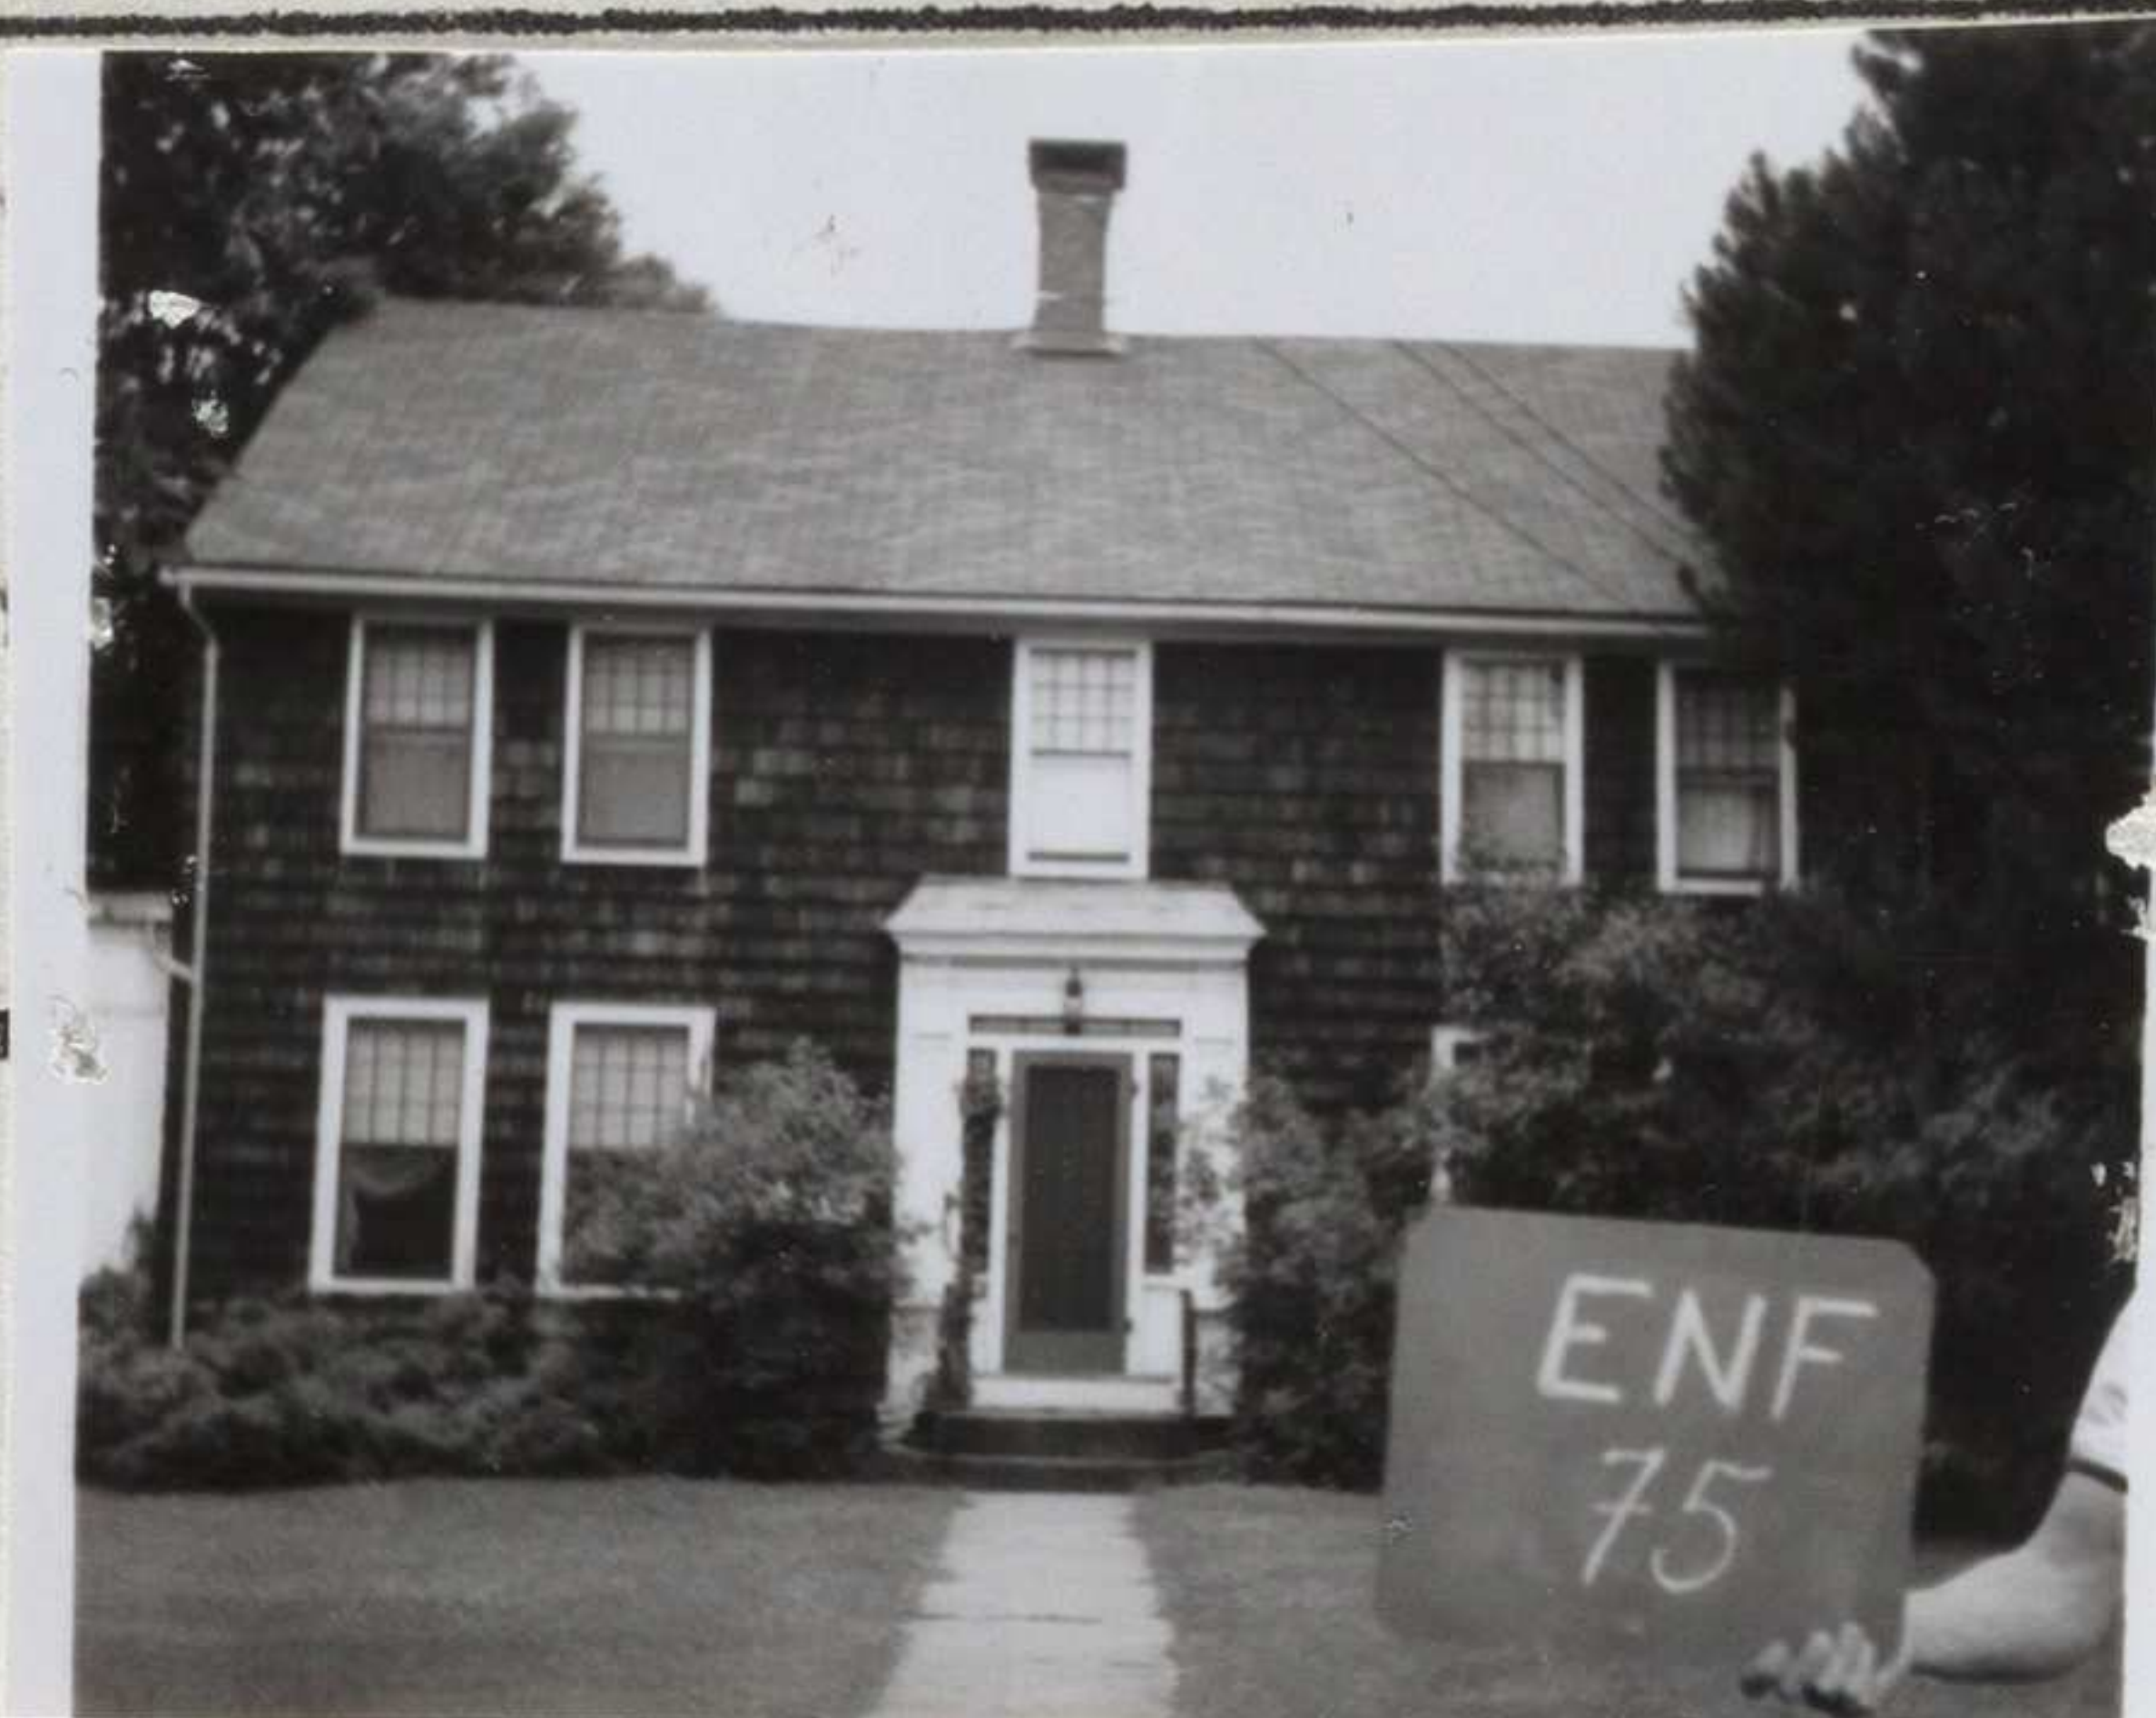
<p>7. PHOTOGRAPH <i>Enf 75</i></p>
<p>8. PUBLISHED SOURCES (Author, Title, Pages) INTERVIEWS, RECORDS, PHOTOS, ETC.</p>	<p>9. NAME, ADDRESS AND TITLE OF RECORDER</p> <p><i>Elvie J. Endersby</i> <i>Director Endersby</i></p> <p>DATE OF RECORD <i>7/13/67</i></p>

<p>1. STATE <i>Ct</i> COUNTY <i>Hartford</i> TOWN <i>Enfield</i> VICINITY STREET NO. <i>1346 Enfield Street</i></p> <p>ORIGINAL OWNER <i>Dr. Simeon Field</i> ORIGINAL USE <i>Residence</i> PRESENT OWNER <i>White</i> PRESENT USE <i>Residence</i> WALL CONSTRUCTION <i>shingles</i> NO. OF STORIES <i>2</i></p>	<p>HISTORIC AMERICAN BUILDINGS SURVEY INVENTORY</p> <p>2. NAME <i>Simeon Field House</i></p> <p>DATE OR PERIOD <i>1763</i> STYLE <i>Colonial Georgian</i> ARCHITECT BUILDER</p> <p>3. FOR LIBRARY OF CONGRESS USE</p>
<p>4. NOTABLE FEATURES, HISTORICAL SIGNIFICANCE AND DESCRIPTION</p> <p>OPEN TO PUBLIC <i>No</i></p> <p><i>This very old house is built on a brownstone foundation. The five bay dwelling has a medium pitched roof with a new central chimney. There remain a few of the original 12/12 windows, framed in simple moldings. A new door with transom and side lights has been placed within the original door frame which unfortunately extends up only as far as the cornice. The house has recently been shingled over detracting greatly from its beauty. Due to its location at the corner of Bridge St., it was for many years the Allen Inn.</i></p>

<p>5. PHYSICAL CONDITION OF STRUCTURE Endangered ? Interior <i>Poor</i> Exterior <i>Poor</i></p>

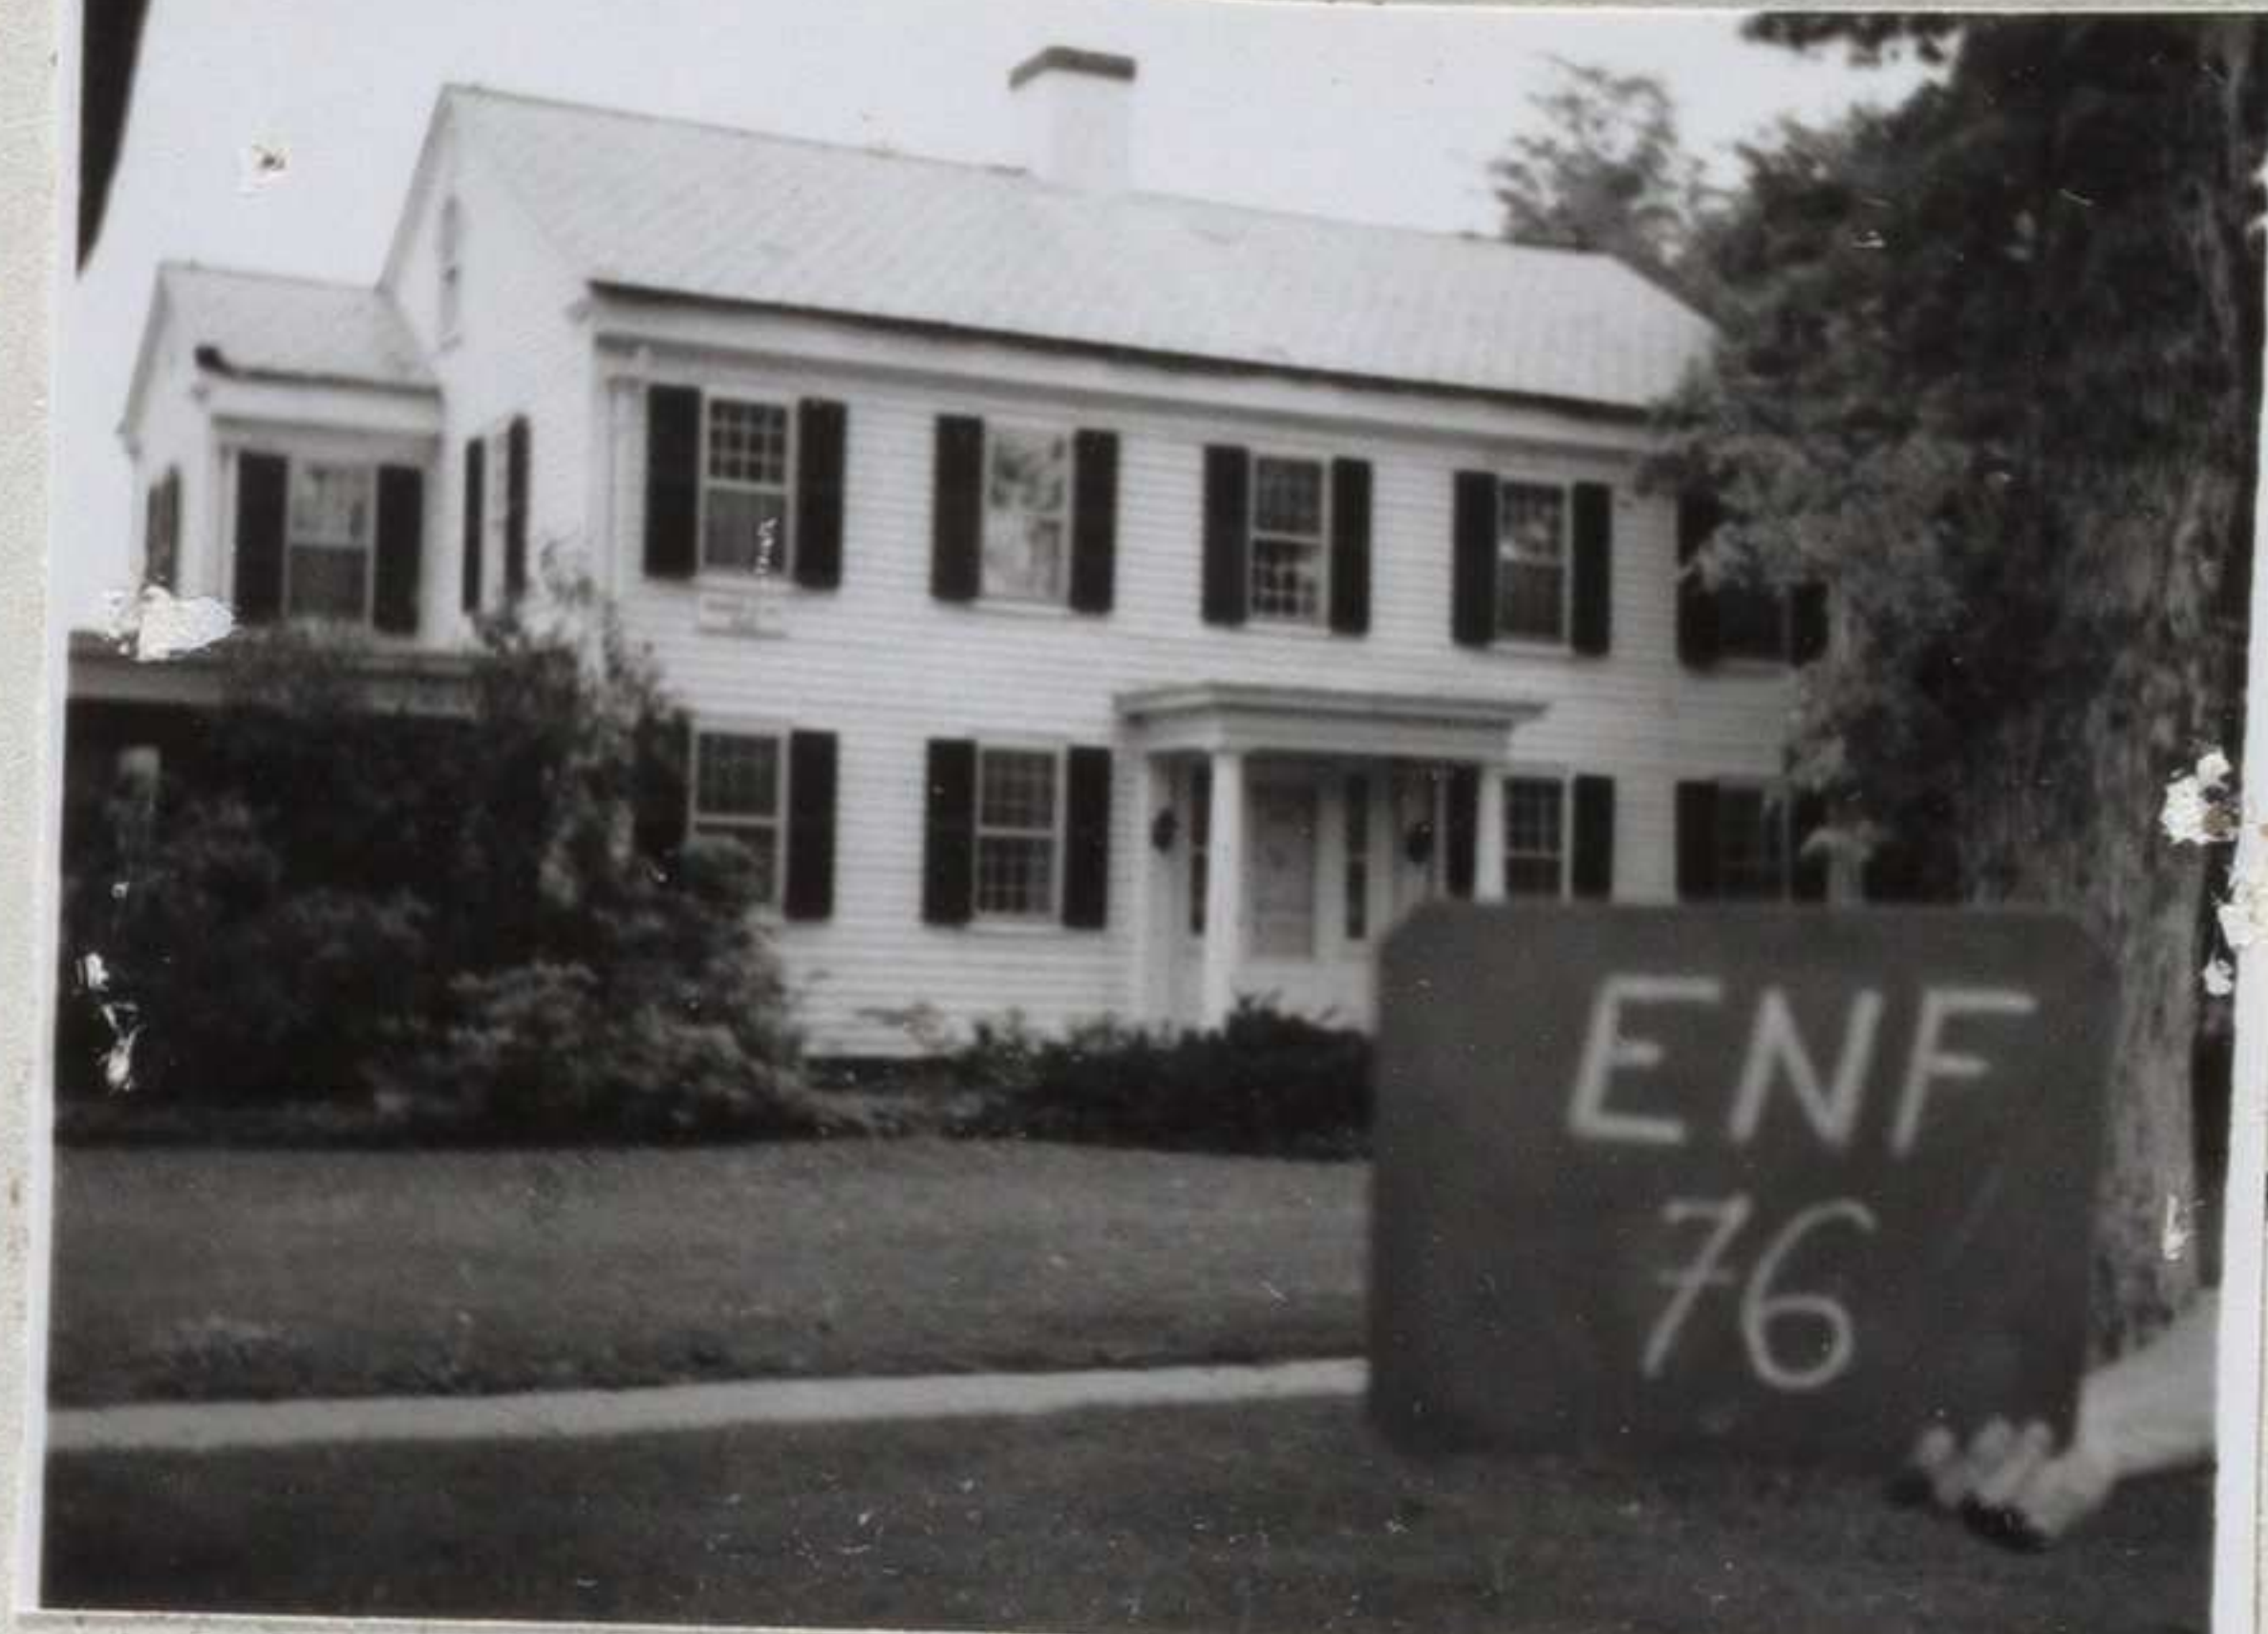
<p>7. PHOTOGRAPH <i>Enf 76</i></p>

<p>1. STATE <i>CT</i> COUNTY <i>Hartford</i> TOWN <i>Enfield</i> VICINITY STREET NO. <i>1352 Enfield Street</i> ORIGINAL OWNER <i>Normand Allen</i> ORIGINAL USE <i>Residence</i> PRESENT OWNER PRESENT USE <i>Residence</i> WALL CONSTRUCTION <i>clapboarding</i> NO. OF STORIES <i>2</i></p>	<p>HISTORIC AMERICAN BUILDINGS SURVEY INVENTORY</p> <p>2. NAME <i>Normand Allen House</i> DATE OR PERIOD <i>1830</i> STYLE <i>Federal</i> ARCHITECT BUILDER</p> <p>3. FOR LIBRARY OF CONGRESS USE</p>
<p>4. NOTABLE FEATURES, HISTORICAL SIGNIFICANCE AND DESCRIPTION OPEN TO PUBLIC <i>No</i></p> <p><i>Built by Normand Allen and later altered by his wealthy descendant by the same name this house is has both periods to contend with. The latter owners alterations were well executed and is difficult to determine the extent of this work. Built on a brown-stone foundation, the house is in five bays. The roof angle is shallow and the dentiled cornice out linings was unfortunately being removed while this survey was being conducted. The windows are 12/12's and there are attic window which are lovely but probably new since the tracery in the arches is of a design found almost solely in Maryland, Virginia, Georgetown and further South. (see back). The roof is slate, (cover)</i></p> <p>5. PHYSICAL CONDITION OF STRUCTURE Endangered <i>No</i> Interior <i>good</i> Exterior <i>good</i></p>

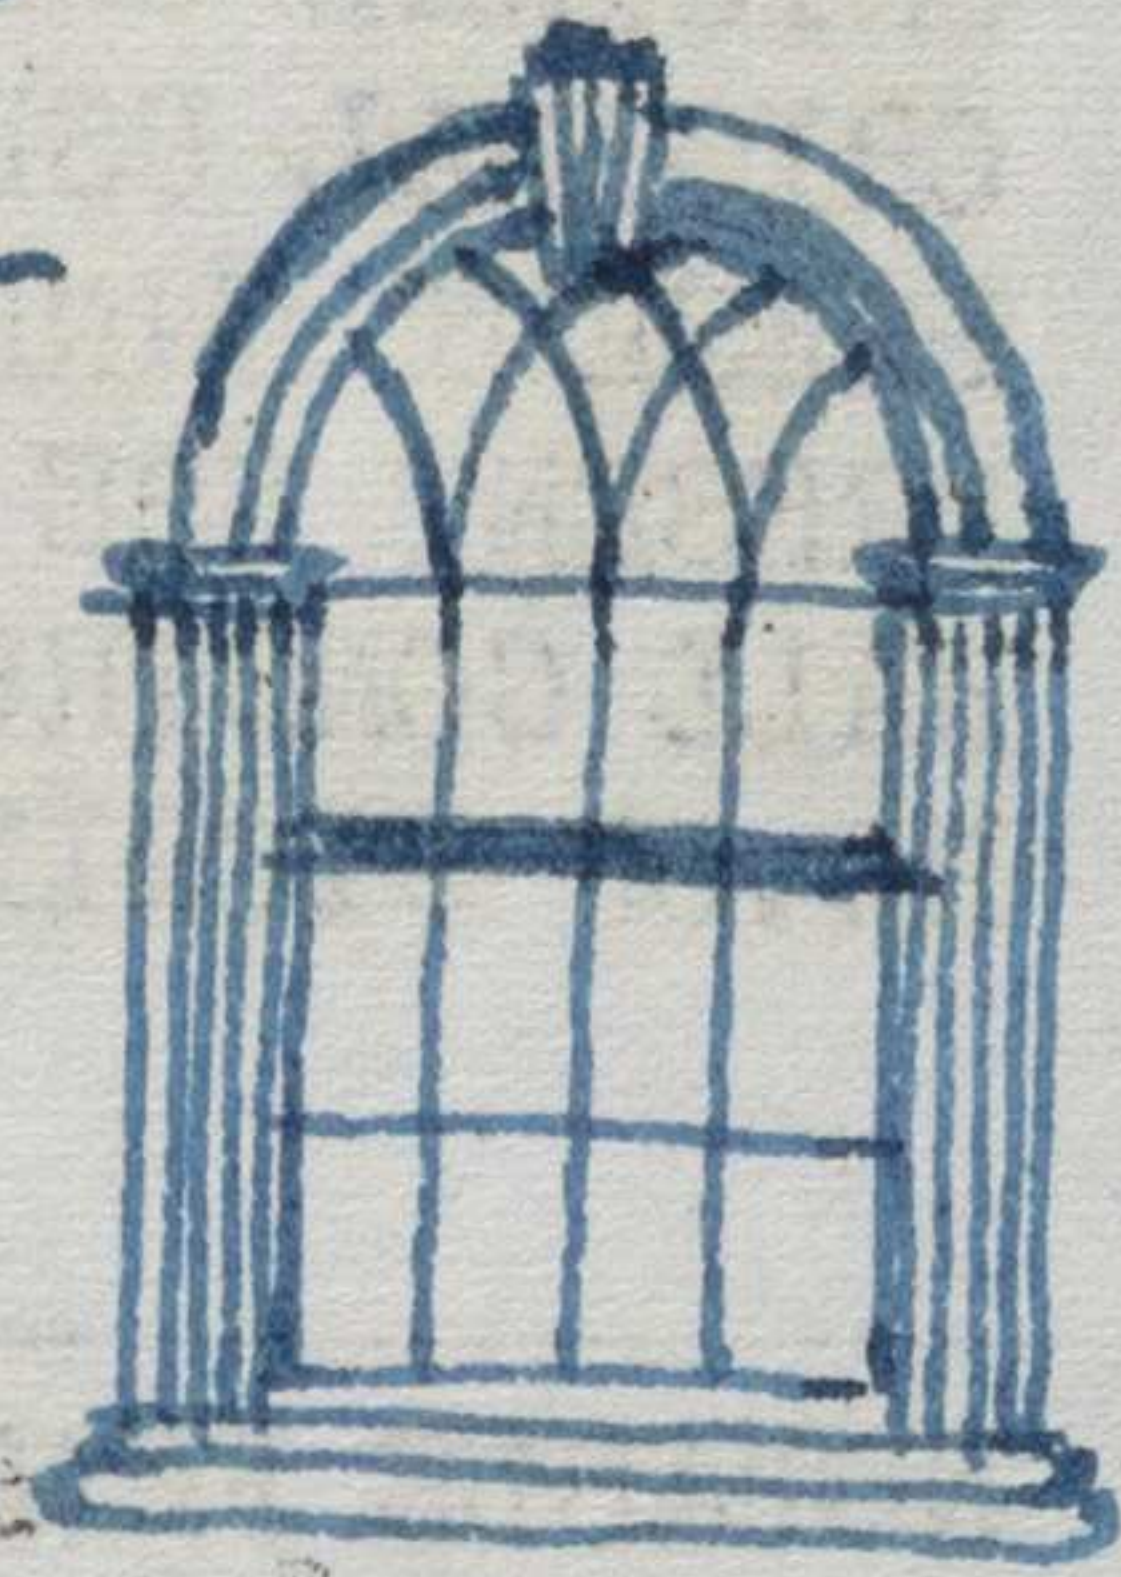
~~attic~~
attic
pediment
window

and there is a central chimney which may well be original. The doorway with its obviously new portico has the same sidelight design as the house moved and restored for the Allen's daughter which then brings to mind the nagging doubt as to the originality of both doorways. In any case the door itself is almost certainly original. There are added porches and additions to the rear.

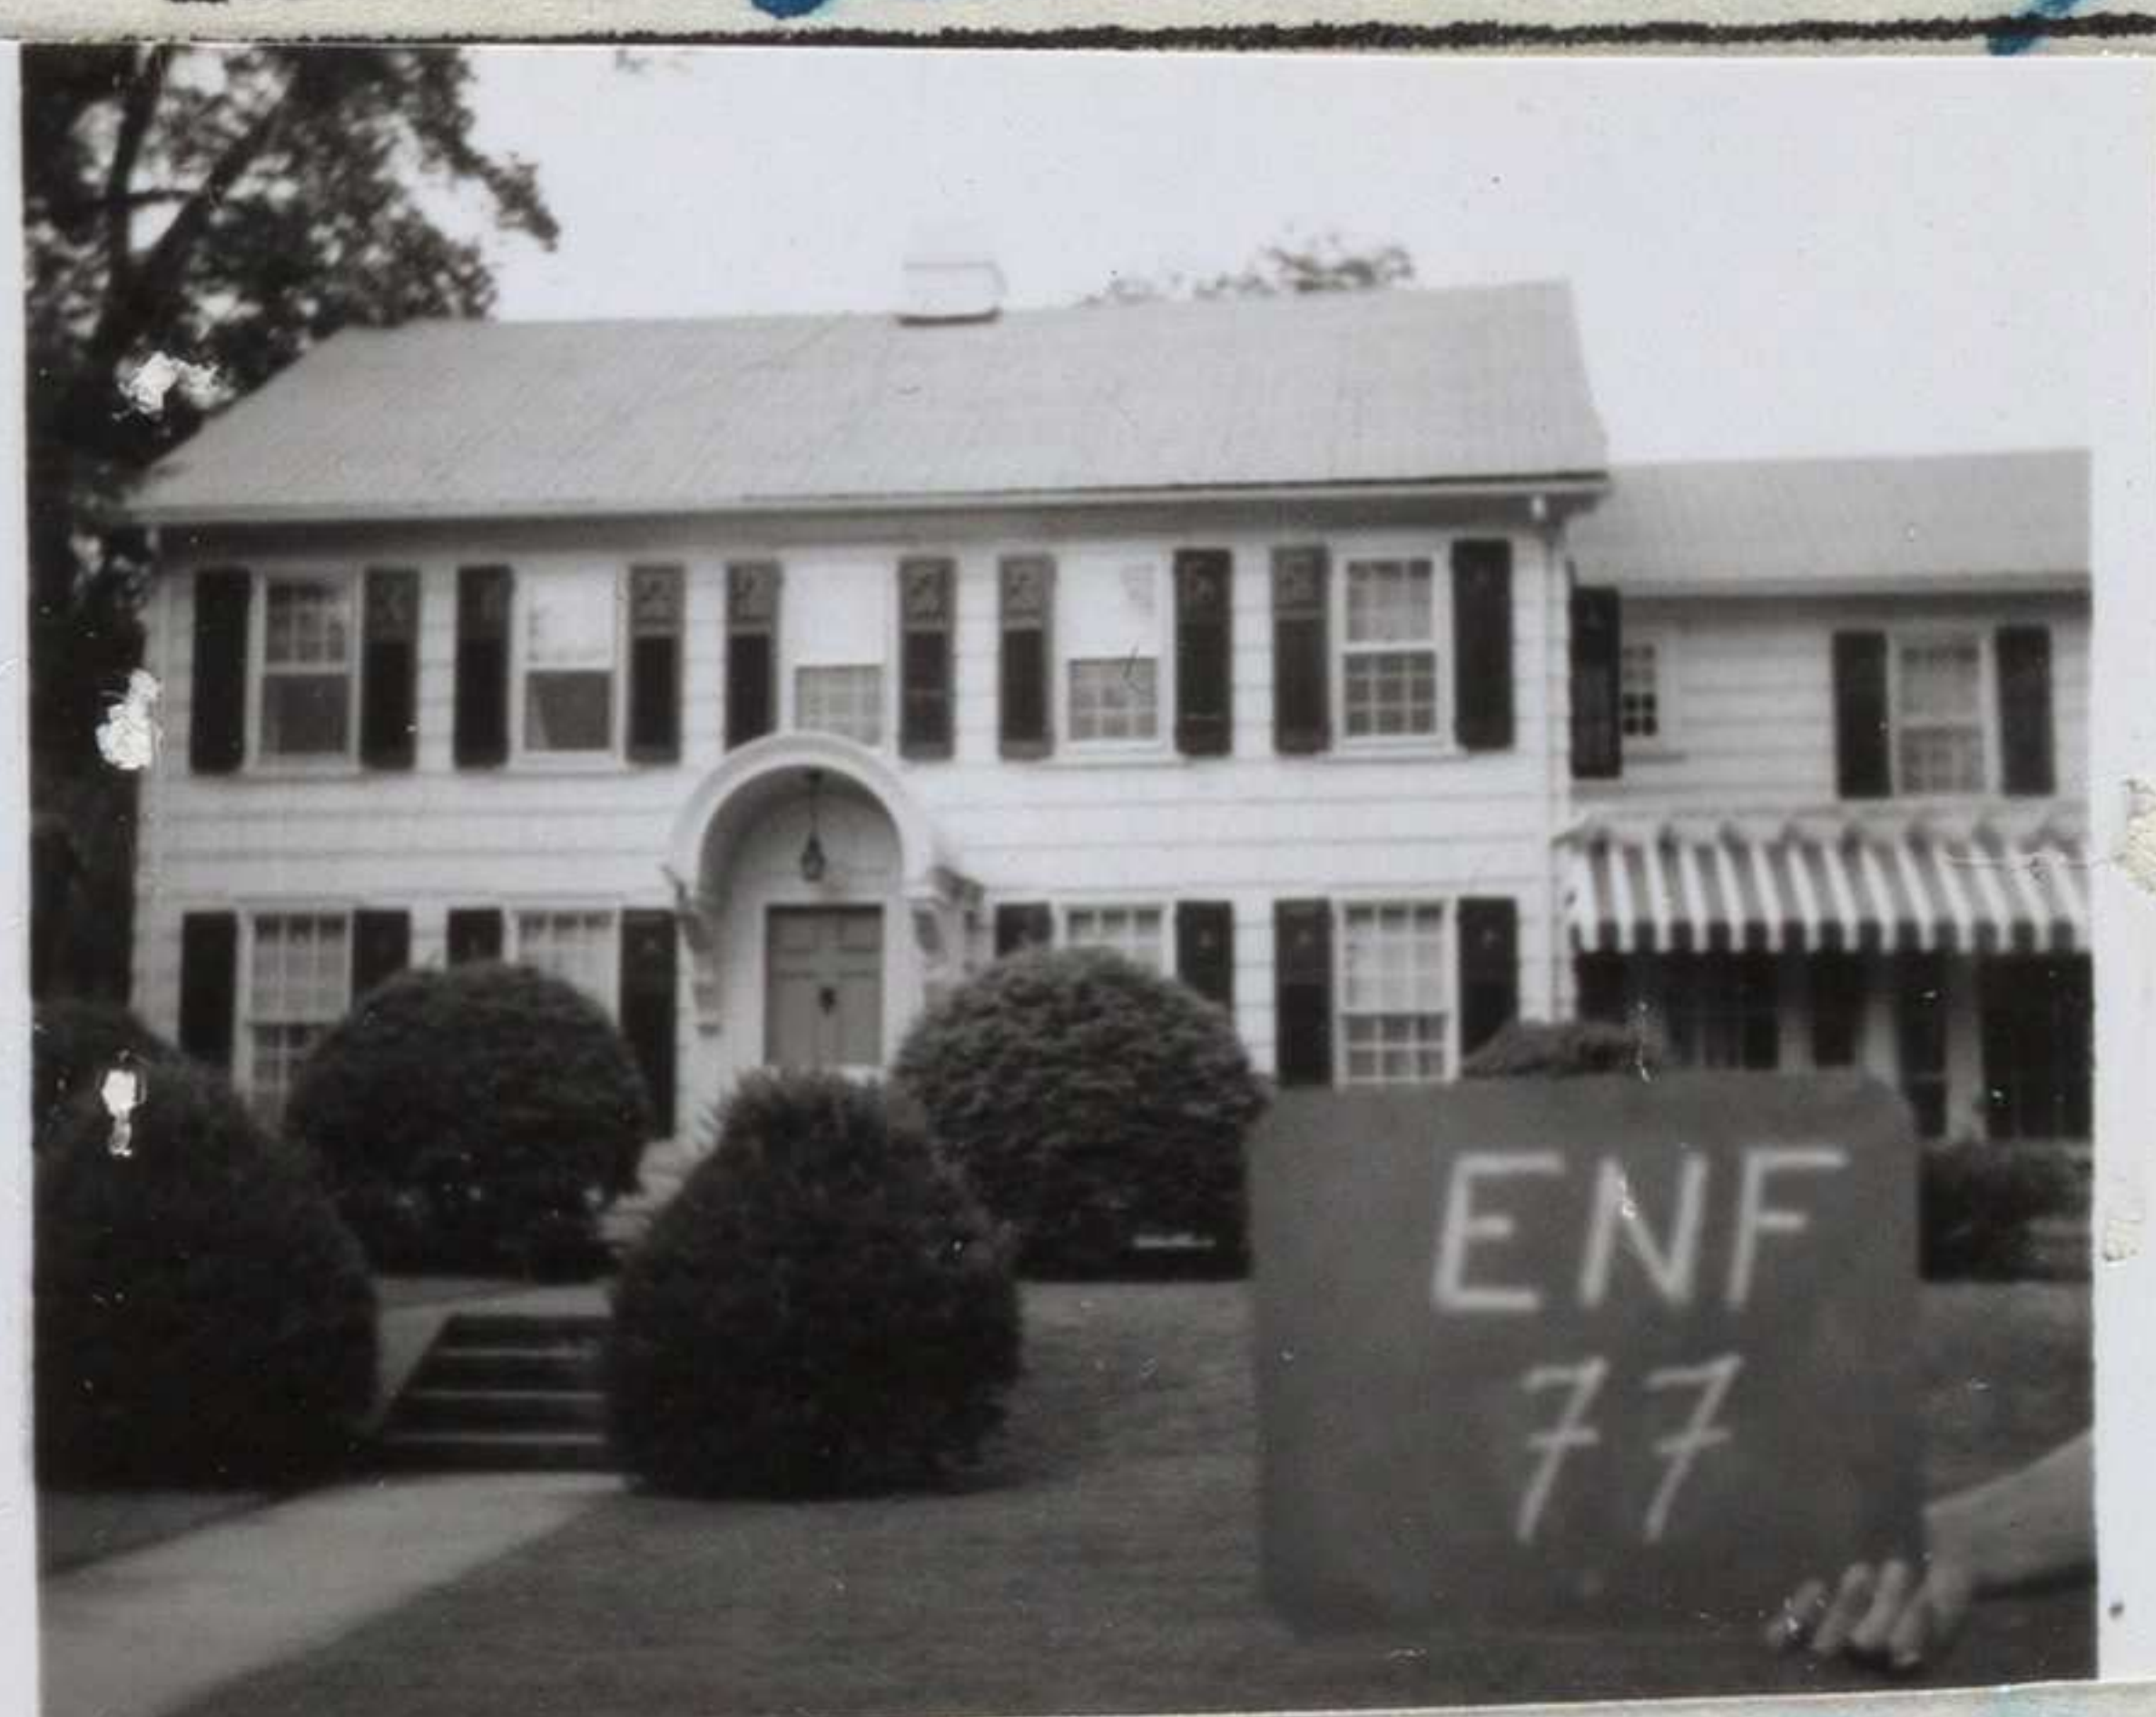
</div>		<div>7. PHOTOGRAPH <i>Enf 77</i></div> <div>

<div>1. STATE <i>Ct</i> COUNTY <i>Hartford</i> TOWN <i>Enfield</i> VICINITY STREET NO. <i>Enfield St.</i> ORIGINAL OWNER <i>Benjamin Parsons Jr.</i> ORIGINAL USE <i>Residence</i> PRESENT OWNER <i>?</i> PRESENT USE <i>Residence</i> WALL CONSTRUCTION <i>shingles</i> NO. OF STORIES <i>2</i></div>		<div>HISTORIC AMERICAN BUILDINGS SURVEY INVENTORY</div> <div>2. NAME <i>Ben! Parsons Jr. House</i> DATE OR PERIOD <i>1705</i> STYLE <i>Georgian Colonial</i> ARCHITECT BUILDER</div> <div>3. FOR LIBRARY OF CONGRESS USE</div>	
<div>4. NOTABLE FEATURES, HISTORICAL SIGNIFICANCE AND DESCRIPTION</div> <div>OPEN TO PUBLIC <i>No</i></div> <div><i>Aside from the brownstone foundation we were un- certain as to whether this was, in fact, an early house or a 1920's copy, so extensive was the "restoration" at that time. The features are there but they are so cute as to be deceiving. Later due to the help of our 90 year old friend, Mrs. Stewart we were able to confirm it as one of Enfield's earliest houses. It is in five bays with a medium pitched roof and replaced central chimney. The windows on the facade are 9/9; to the side they are new and oversized. The added features include: wing, porch, portico, door, shutters, shingles, roof.</i></div>

<div>5. PHYSICAL CONDITION OF STRUCTURE</div> <div>Endangered <i>?</i> Interior <i>fair</i> Exterior <i>poor</i></div>			
<div>6. LOCATION MAP (Plan Optional)</div> <div>

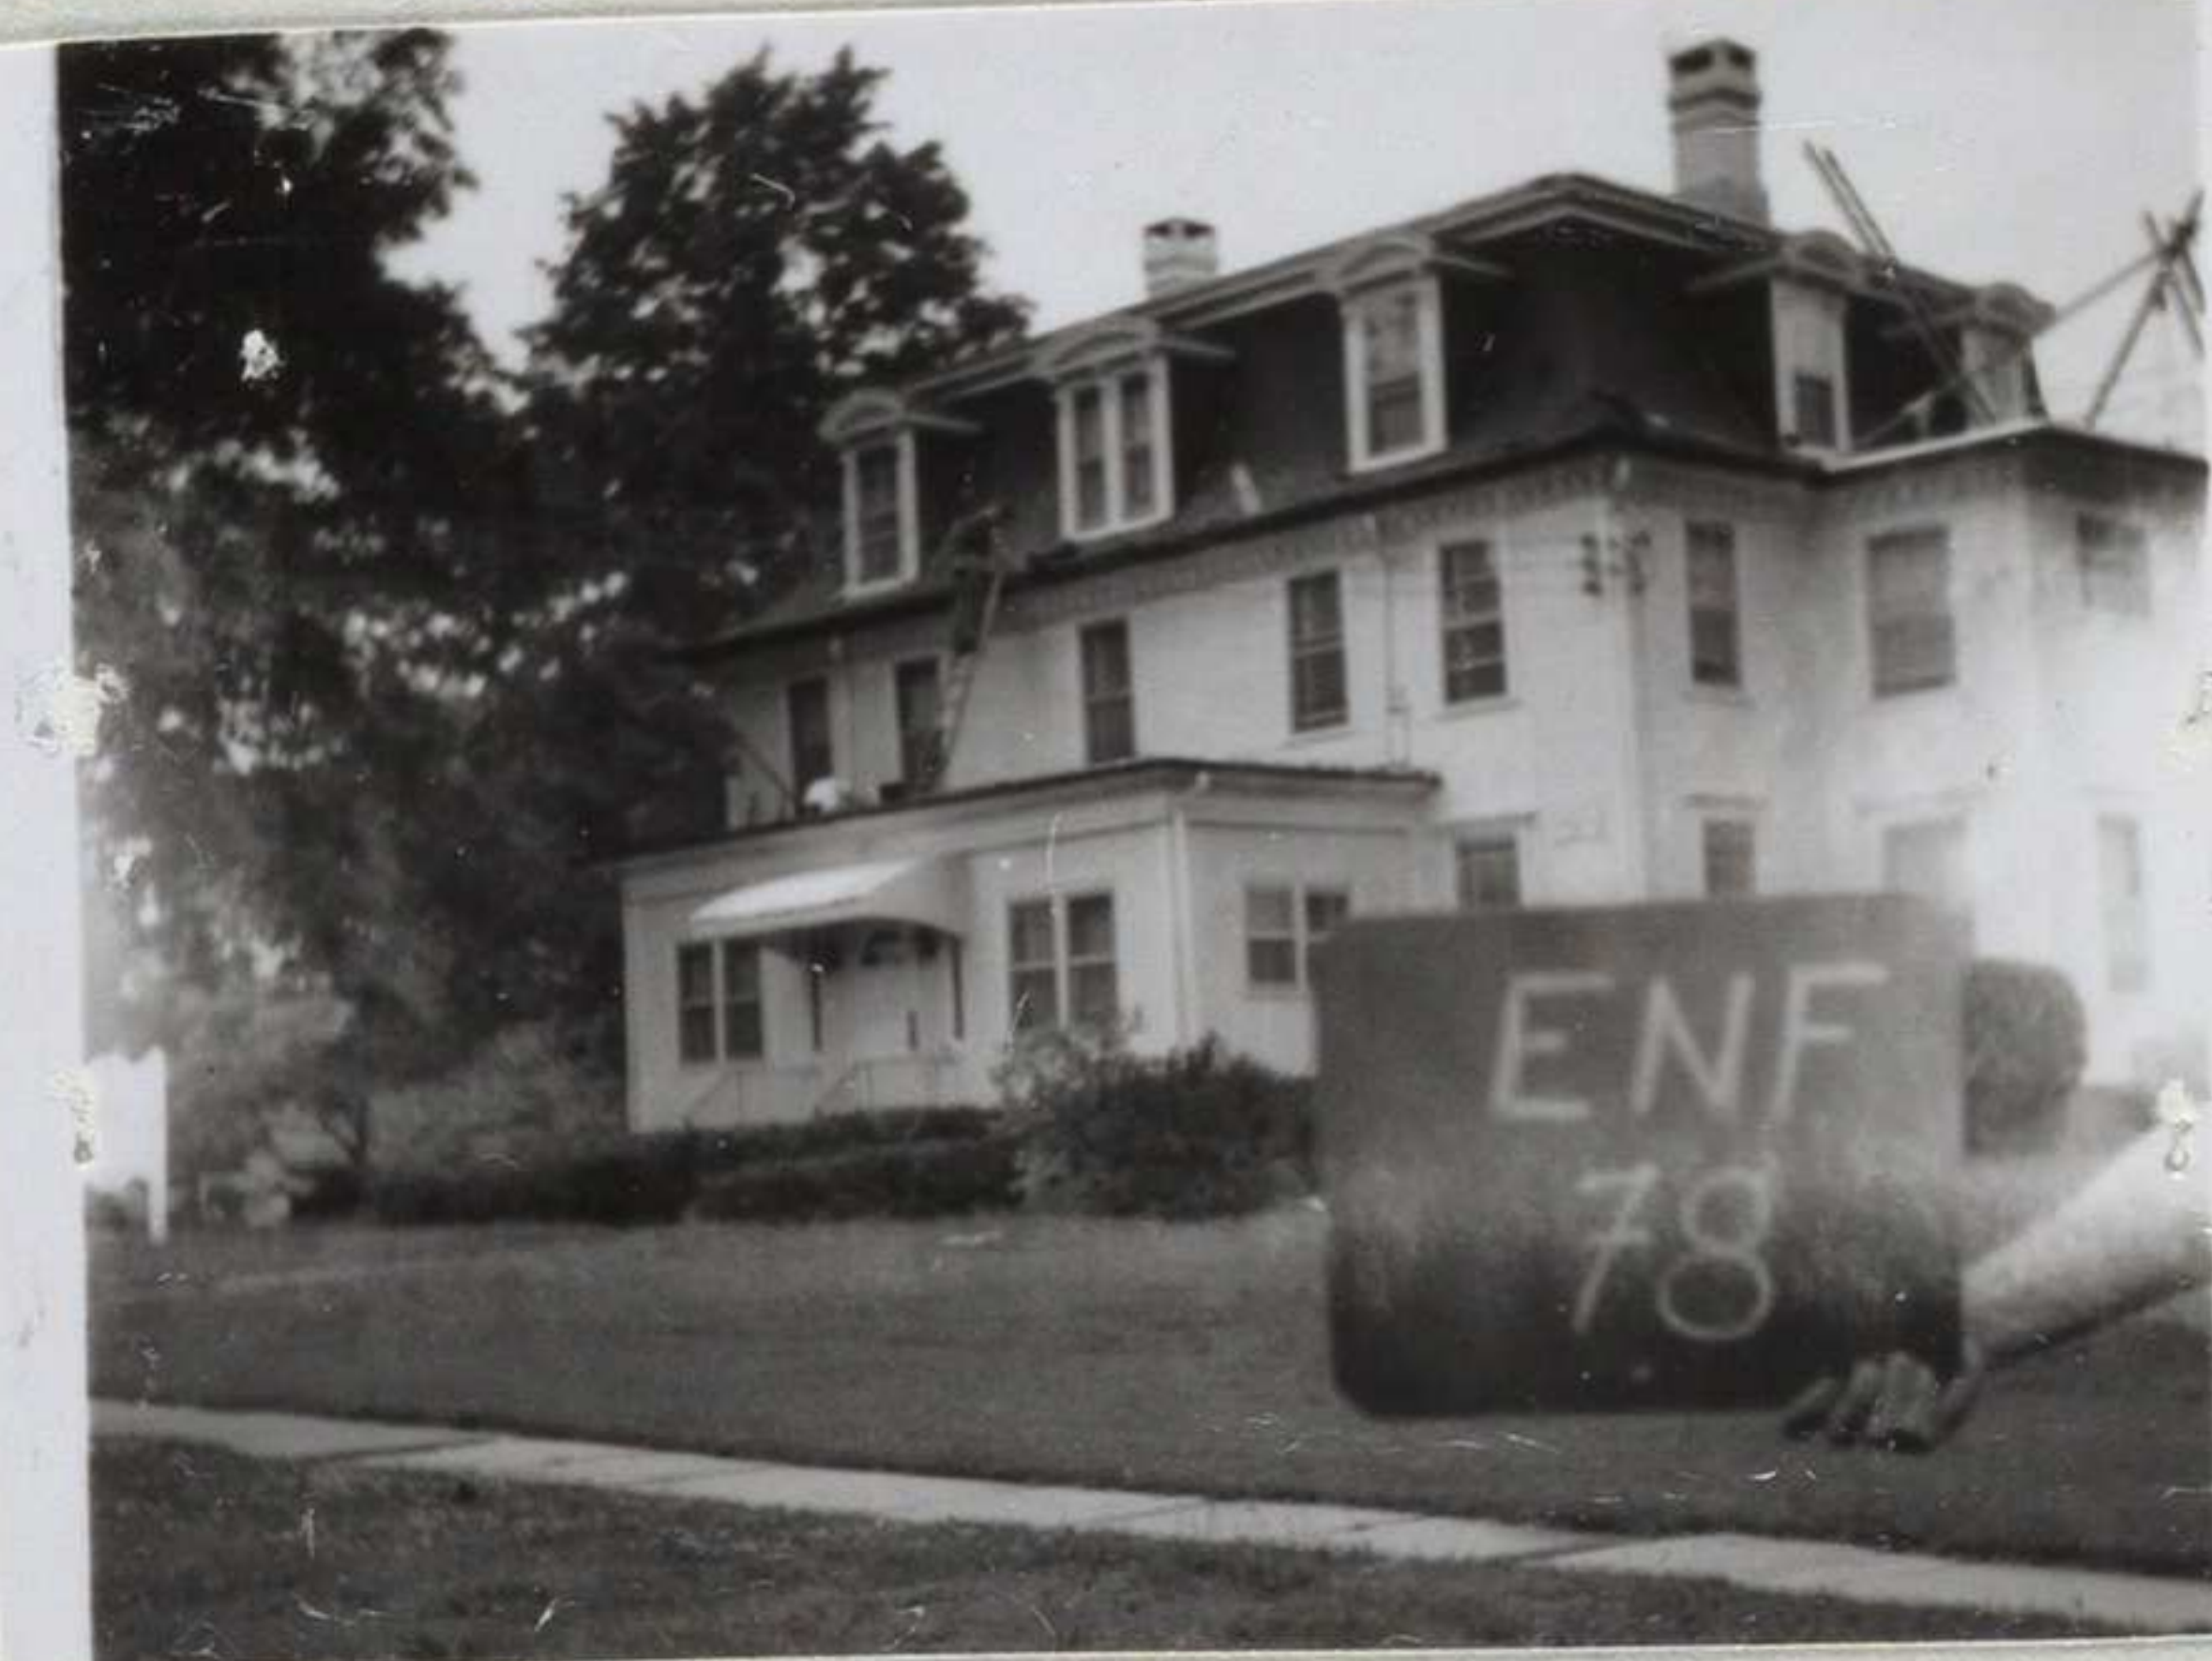
7. PHOTOGRAPH *Enf 78*

This poor house has been added to and altered during many periods; too many! It is the last of the three houses to be built by Ephraim Pease for his daughters. This one was built for Agnes on her marriage to the Rev. Prudden. All that can be seen of the original house today is its brown-stone foundation and five bay form. A mansard roof was added during the 19th century and the taste-lacking Sisters have added porches, bays, front rooms, cornice, and doors windows etc, etc.*

Endangered ? Interior *poor* Exterior *poor*
